Commanding Officer  
U.S. Coast Guard  
Marine Safety Office

Subj: FORMAL INVESTIGATION INTO THE COMMERCIAL DIVING ACCIDENT  
ABOARD THE MOBILE OFFSHORE DRILLING UNIT CLIFF'S DRILLING  
RIG NO. 12 ON 4 MARCH 1996, WITH LOSS OF LIFE.

**FORMAL INVESTIGATION INTO THE COMMERCIAL DIVING ACCIDENT ABOARD  
THE MOBILE OFFSHORE DRILLING UNIT CLIFF'S DRILLING RIG NO. 12 ON  
4 MARCH 1996, WITH LOSS OF LIFE**

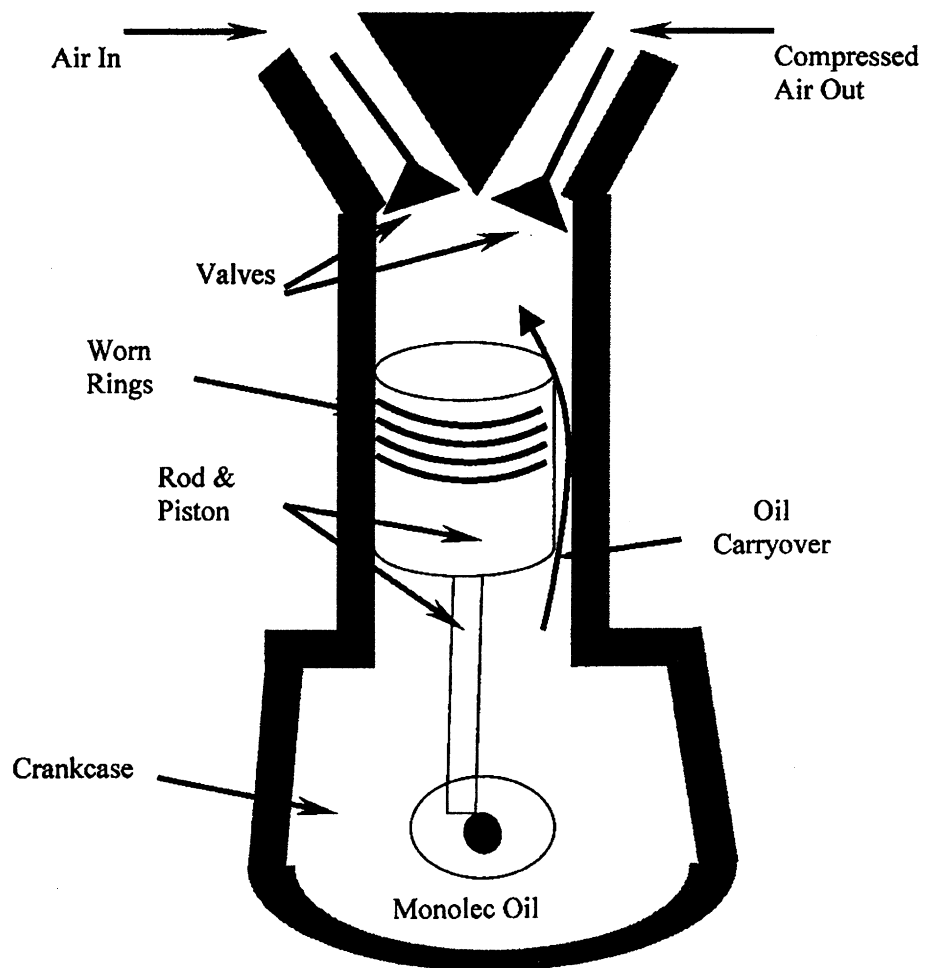
**Figure 8: Representation of piston / cylinder assembly**

13. All oil lubricated low-pressure air compressors used for surface supplied diving are equipped with two types of filters. At the suction side (air inlet) of the compressor an intake air filter prevents the air compressor from ingesting contaminants. Additionally, oil-lubricated compressors used for diving are equipped with a moisture/oil separator and a discharge filter. The moisture separator removes most of the condensation formed during the compression. The moisture/oil separator and filter also remove much of the lubricating oil that mixes with the condensate resulting in an emulsification. The discharge filter serves two functions: it filters particulates that pass through or are generated inside the compressor due to wear or damaged components, and picks up the final traces of oil that get by the moisture/oil separator. Moisture/oil separators require very little maintenance while the discharge filter requires periodic changes in accordance with the manufactures recommended intervals.
