Commanding Officer  
U.S. Coast Guard  
Marine Safety Office

Subj: FORMAL INVESTIGATION INTO THE COMMERCIAL DIVING ACCIDENT  
ABOARD THE MOBILE OFFSHORE DRILLING UNIT CLIFF'S DRILLING  
RIG NO. 12 ON 4 MARCH 1996, WITH LOSS OF LIFE.

**FORMAL INVESTIGATION INTO THE COMMERCIAL DIVING ACCIDENT ABOARD  
THE MOBILE OFFSHORE DRILLING UNIT CLIFF'S DRILLING RIG NO. 12 ON  
4 MARCH 1996, WITH LOSS OF LIFE**

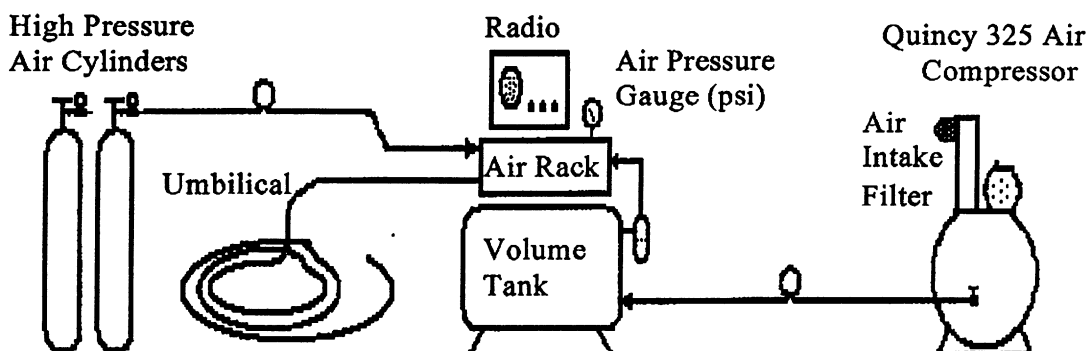
Figure 5: Schematic representation of Dive Station

36. Before the first dive, the dive team discovered their video cable was incompatible with the video equipment on board. They also discovered they had only one dive umbilical on-scene. Wiitala called Gilbert to request a compatible video cable be sent to the site. Wiitala did not raise the issue of the missing second dive umbilical or request another umbilical be sent to the dive site.<sup>90</sup>

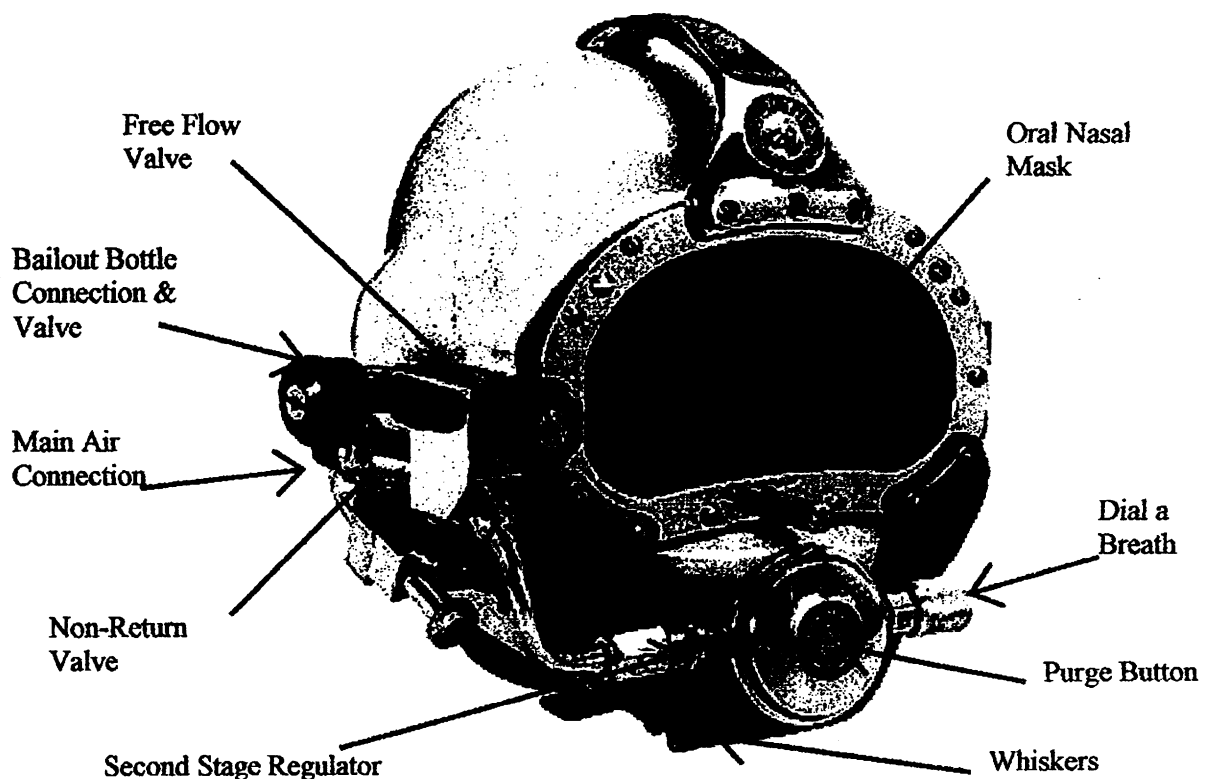
**Figure 6: SuperLite 27 Dive Hat**

39. At about 1330 hours, Pilkington entered the 65 to 70 degree water for the first time.<sup>95</sup> Pilkington wore a neoprene wet suit and his own Kirby, Morgan SuperLite 27 Dive Hat (See Figures 6 & 7).<sup>96</sup> He also wore Wiitala's weight belt and a harness with a quick release to which the umbilical, a knife and axe were attached. A three-foot lanyard attached the roofing axe to the diver's belt.<sup>97</sup>

4. Finally, water may have entered Pilkington's helmet through the emergency air connection. In a last ditch attempt to trouble-shoot his emergency, Pilkington may have reached for the emergency valve handle directly adjacent to the main air connection. This connection is typically used to couple the bailout bottle to the helmet. When not used, the only barrier preventing water from entering the helmet is the emergency supply valve (See figure 7). When Pilkington's regulator bottomed out, he may have instinctively opened his emergency supply valve, the standard procedure taught in commercial dive schools, and allowed water to enter his helmet. If the emergency valve was opened, water would only have entered the helmet if the air pressure inside the helmet was extremely low (indicating an almost total interruption in air supply and pressure). Even the smallest pressure above ambient would have forced air out of the emergency valve which would have prevented water from entering.<sup>164</sup>

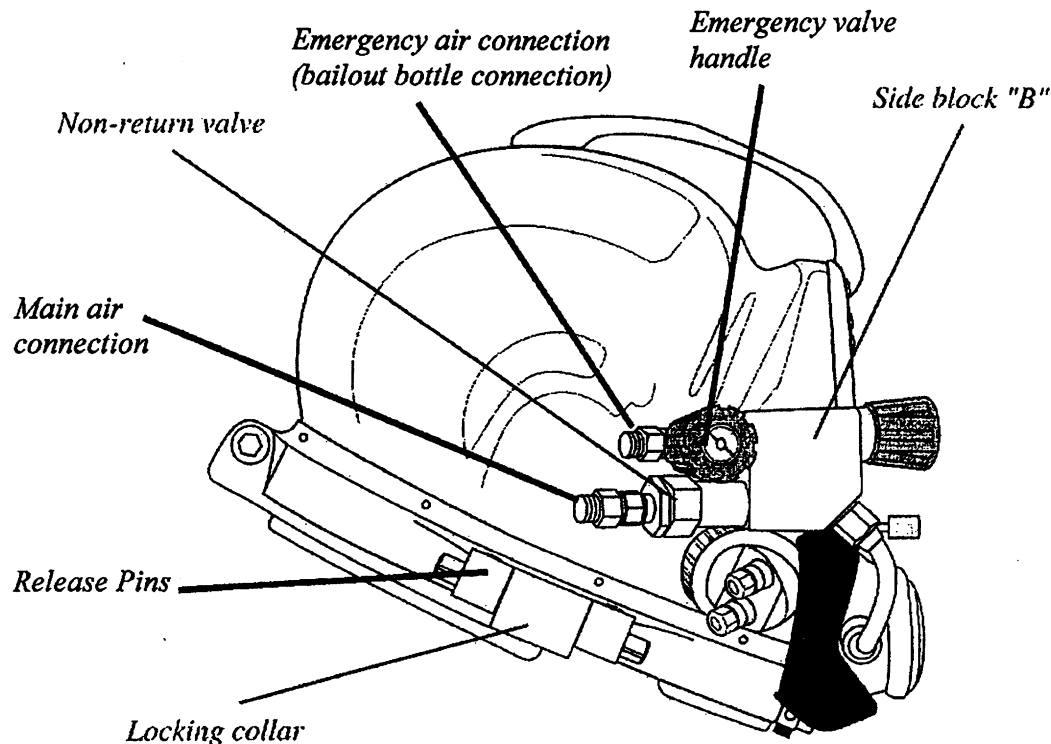
Figure 7: Side view of SuperLite-27 helmet

31. Wiitala's testimony raised the questions of whether Pilkington's main airline was secured to his helmet when he began his dive and whether Pilkington may have loosened the connection when he was underwater. Wiitala testified that before Pilkington quit talking, Pilkington said that he might have forgotten to tighten his airline.<sup>212</sup> The reasoning is that Pilkington may have reached up to his main air connection (See figure 7) and, while trying to tighten the fitting, loosened it instead. Master Chief Bradford opined that it was "plausible" that Pilkington had loosened his main airline connection near the end of his dive.<sup>213</sup> I disagree. The eyewitness testimony on this issue is contradictory, but some facts are undisputed. Townsend says that when he tried to pull Pilkington into the personnel basket, Pilkington's safety harness came free and the umbilical detached from Pilkington's helmet. Champagne, on the other hand, clearly remembers the hoses being connected to Pilkington's helmet when Champagne reached to remove the helmet on the deck of Rig 12.<sup>214</sup> Wiitala saw Pilkington's helmet underwater during the rescue and distinctly remembers seeing the line attached to the helmet and bubbles coming from the "whiskers" of Pilkington's helmet -- indicating that air was going through the helmet fitting to Pilkington's respirator.<sup>215</sup>
